**US Army Corps
of Engineers®**
Engineer Research and
Development Center

Feasibility Investigation into Strengthening of Timber Bridge Stringers

Final report

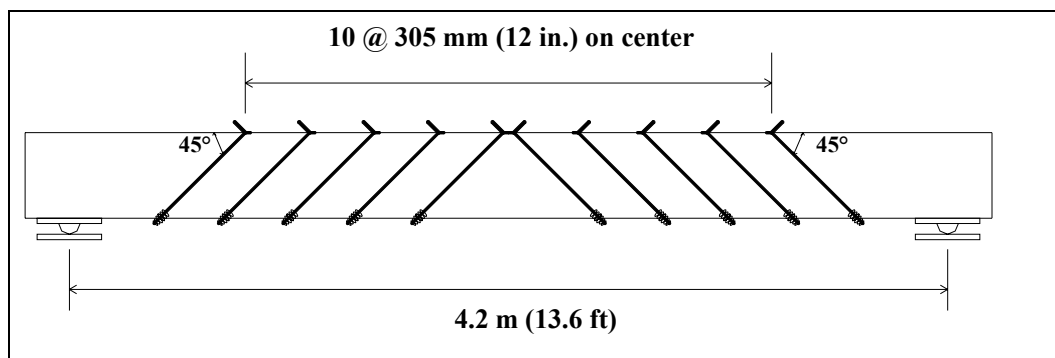
Figure 47. Schematic of lag screws layout for specimen C10-R.

Specimens C7-R and C10-R were repaired with lag screws. Specimen C10-R was repaired in the same fashion as specimen C7-R, but the 45° angle of the lag screws was installed in the opposite direction, as shown

schematically in Figures 46 and 47. A total of 10 lag screws were used to repair both timber stringers. The lag screws were 13 mm (1/2 in.) in diameter and 610 mm (24 in.) long. After marking points spaced at every 610 mm (2 ft) on the top of the stringer, guidelines at 45° to the transverse direction were drawn from the marked points to the bottom of the stringer. Holes making 45° angle with the transverse direction were then drilled along the guidelines using a 13 mm (1/2 in.) wood drill bit and the Hilti TE 2 drilling tool. Epoxy was not used with lag screws. The repaired stringer with lag screws is shown in Figure 48.

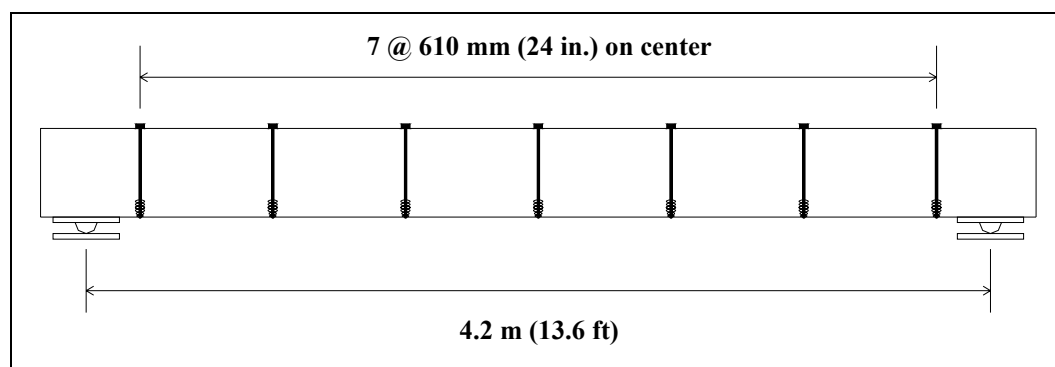
Figure 49. Schematic of lag screws layout for specimens C11-R and C15-R.

Specimens C11-R and C15-R were repaired with 406 mm (16 in.) long lag screws similar to specimens C6-R. Figure 49 shows a schematic representation of the repairing method. Lag screws were placed at every 610 mm (2 ft) along the length of the stringer for a total of 13 lag screws.

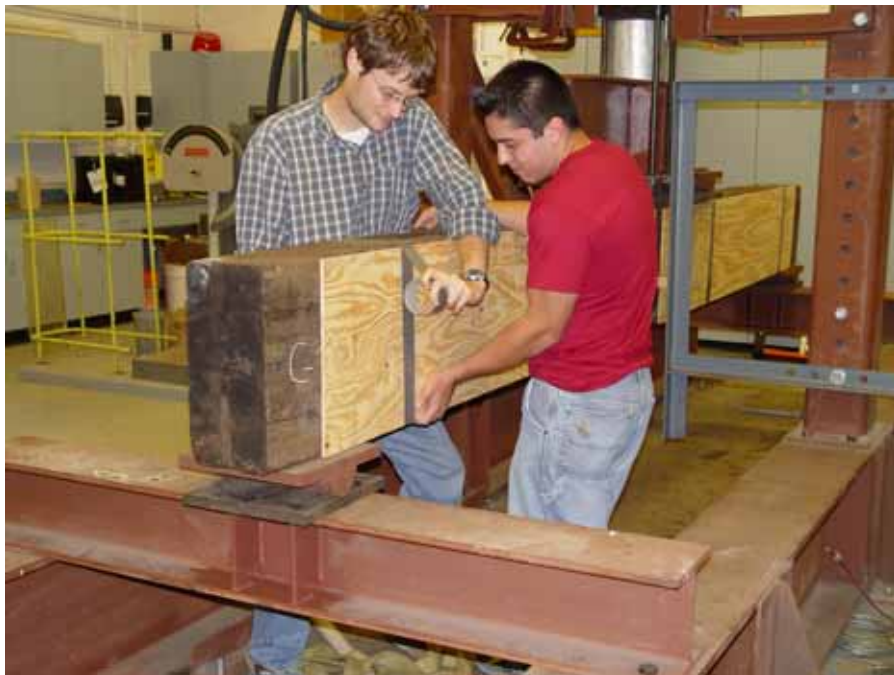
Figure 50. Lag screws being installed to specimen C13-R.

Four plywood side plates were attached to the sides of stringer C13-R. The plywood was first cut into 406 mm by 2,057 mm (16 in. by 81 in.) plates. The plates were then duct taped to the sides of stringer C13, and 76 mm (3 in.) long lag screws were used to attach the side plates to the stringer

using a TE 35 drill, as shown in Figures 50 and 51. Schematic of the plywood side plate layout is shown in Figure 52. A total of 14 lag screws were used to attach each plywood plate to the sides of the stringer. The plywood plates were not used over the entire length to prevent buckling in the midspan, as shown in Figure 53.

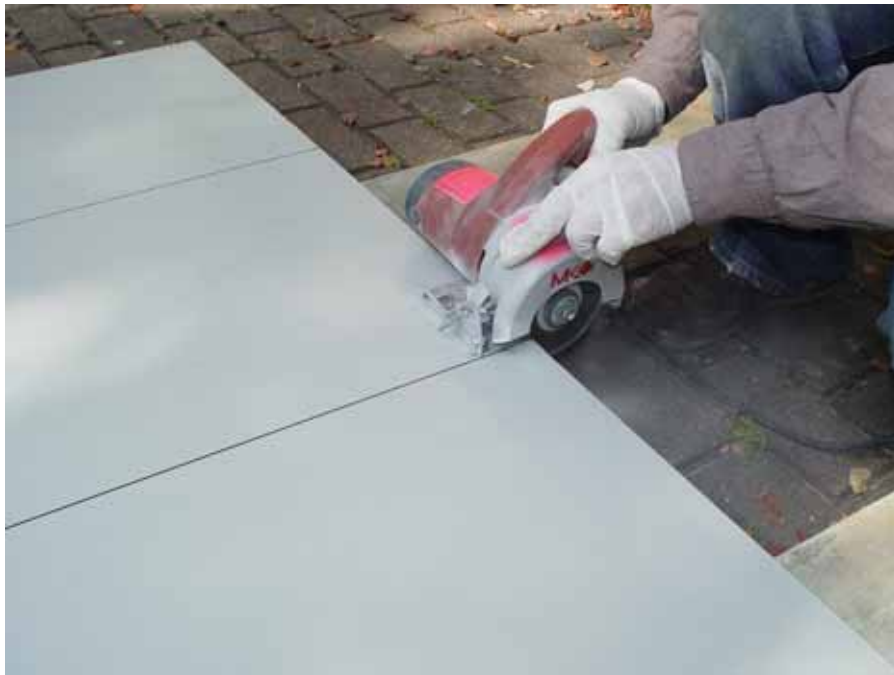
Figure 54. FRP plates being cut to size.

Specimens C14-R and C16-R were repaired with four FRP plates attached to the sides of the stringers. The FRP plates were first cut into 406 mm by 1,829 mm (16 in. by 72 in.) plates, as shown in Figures 54.

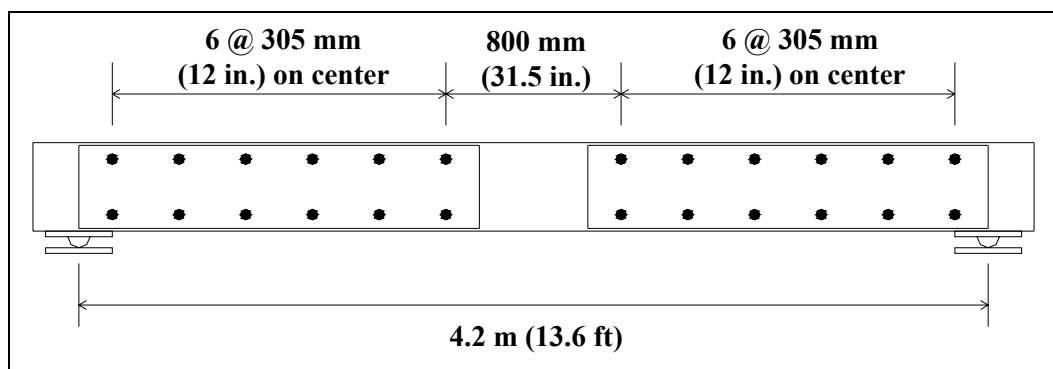
Figure 55. Schematic of FRP side plates for specimens C14-R and C16-R.

The FRP plates were attached to sides of the timber stringers using a similar method to that used to attach the plywood plates. Lag screws were used with washers to attach the FRP side plates. The washers were used to protect the FRP plates from damage caused by the heads of the lag screws when tightened. A schematic of the FRP side plate layout is shown in Figure 55. A total of 12 lag screws were used to attach each FRP plate to the side of the stringer. FRP plates were used along the shear span, as shown in Figure 56, leaving a gap at the midspan. The FRP side plates used to repair stringer C14-R did not show any major damage after testing. Therefore, the same plates were used again to repair stringer C16-R.

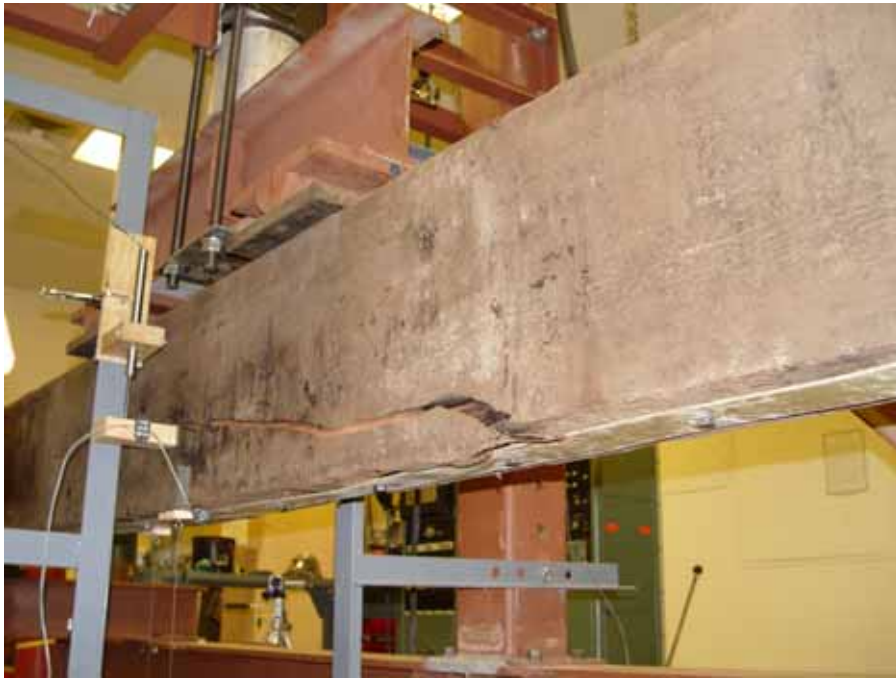
Figure 57. Stringer C12-R repaired at tension zone with FRP strip.

Specimen C12-R was repaired with lag screws and the FRP strip located at the tension zone. Lag screws were used to attach an FRP strip to the tension zone of the stringer. Lag screws were also used to attach the FRP plates as shear reinforcement in this method. Holes were drilled on the FRP strip at every 305 mm (1 ft) using Hilti TE-2 drill and 13 mm (1/2 in.) drill bit. FRP strip were then duct taped underneath the stringer. Holes in the timber were then drilled at 305 mm (1 ft) spacing. The holes were then drilled half way into the depth of the stringer with 13 mm (1/2 in.) diameter drill bit and other half way with a 9.5 mm (3/8 in.) diameter drill bit. After the holes were drilled into the stringer, the lag screws were installed using a Hilti TE-35. Figure 57 shows the repaired stringer with FRP strip attached with lag screws.

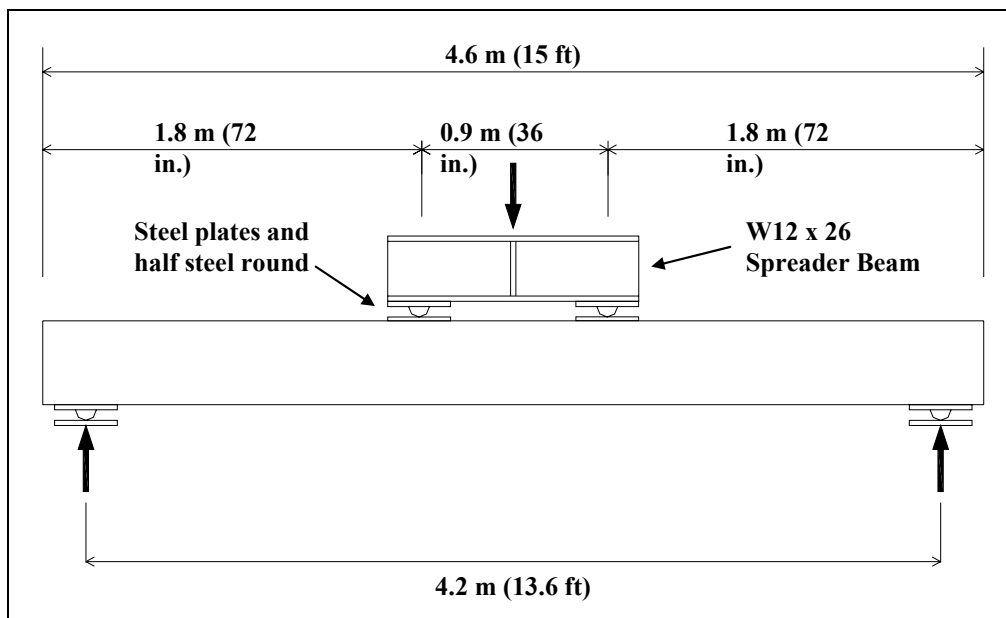
Figure 58. Configuration for the four-point bending test.

A self-reacting test frame was used in all of the tests. The tests were conducted according to ASTM D198 (1999). All stringers were tested on a span of 4.2 m (13.6 ft) with two equal loads applied symmetrically at a distance of 457 mm (18 in.) from the centerline, to create a constant moment region and two shear regions in the stringer. This required the fabrication of a spreader beam to split the applied load into two loads. The test setup is pictured schematically in Figure 58.

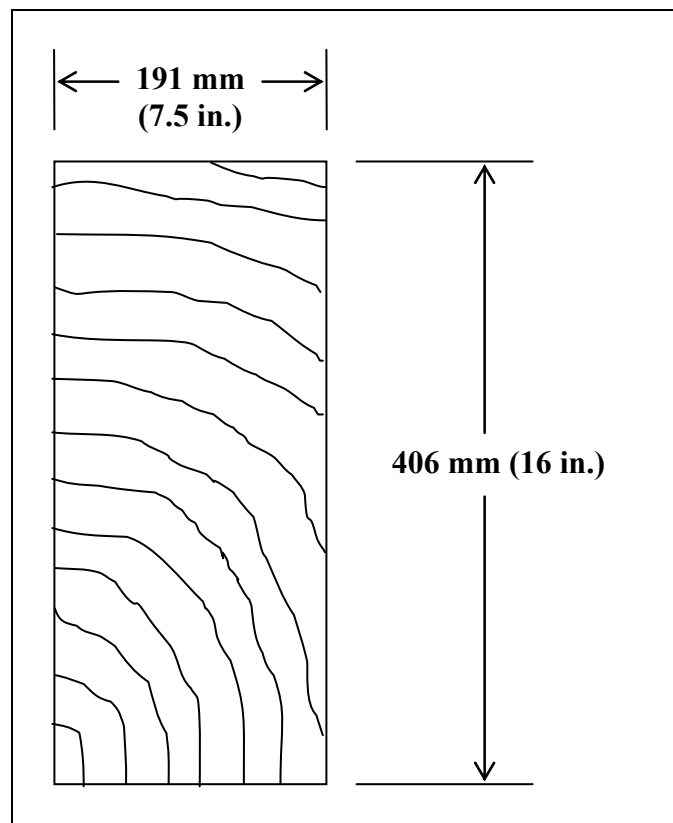
Figure 59. Typical cross section of timber stringers.

support points. Higher loads would have caused excessive compression at the loading points in the direction perpendicular to grain. The stringers had a cross section 191 mm (7.5 in.) wide and 406 mm (16 in.) deep, as shown in Figure 59. The typical configuration of the support plates is also shown in Figure 60.

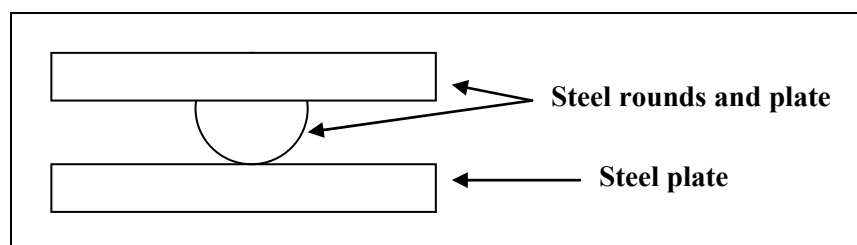
Figure 60. Typical configuration of the support plates.

Half steel rounds, 102 mm (4 in.) in diameter, were used to allow free rotation points for load and reactions. The half steel rounds were attached to 25.4 mm (1 in.) thick steel plates measuring 305 mm by 305 mm (12 in. by 12 in.). Steel plates 305 mm by 305 mm (12 in. by 12 in.) were used to limit the compression stress perpendicular-to-grain at loading and

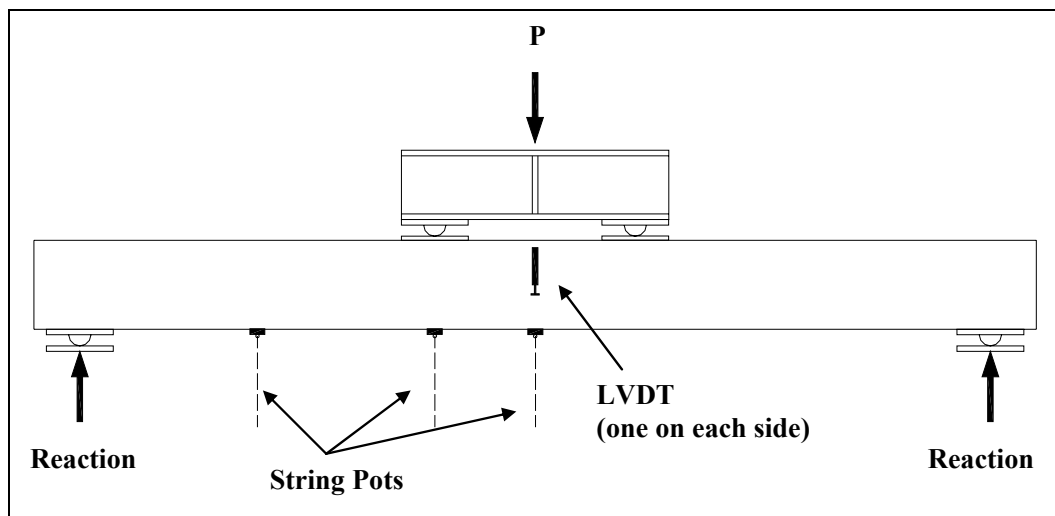
Figure 61. Placement of monitoring equipment on test specimens.

Deflections were measured to examine the behavior of the stringers. Linear variable differential transformers (LVDTs) and string pots were placed at multiple positions of the test setup to monitor displacements. Figures 61 and 62 show the positions of the LVDTs and string pots on the test setup.

String pots consist of a wire cable on a coil attached to a tension spring in an enclosed housing. The tension spring maintains a constant tension on the wire cable. As the cable is drawn out or retracted, an electrical output signal specifying the amount of movement is sent to the data acquisition computer. The UniMeasure, Inc. P510-40-DS string pots were placed on the bottom of the stringers at the midspan, the loading point, and the middle of the shear span. Omega Technologies LD610 LVDTs with a stroke of 102 mm (4 in.) were mounted on the testing frame with the movable ends resting on blocks attached to the stringers on each side at the midspan. As the stringers deflected, the movable end extended, sending an electrical output signal directly related to the amount of the movement to the data acquisition system.

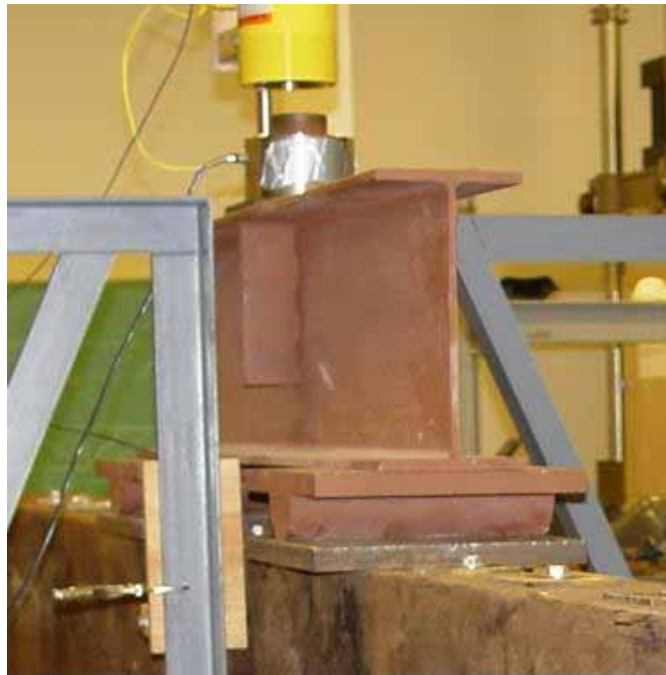
Figure 63. The load cell-hydraulic ram setup with spreader beam.

The load was monitored for the five original timber stringers (C1, C2, C3, C4 and C5) and the four repaired stringers (C2-R, C3-R, C4-R, and C5-R) with a 445 kN (100 kips) load cell, which was placed between the hydraulic ram and the spreader beam. The load cell was manufactured by AmCells Company and was calibrated prior to use. The stringers tested with the MTS actuator utilized a 356 kN (80 kips) load cell which was attached to the actuator. The load cell-hydraulic ram setup is shown in Figure 63, and the actuator is shown in Figure 64.

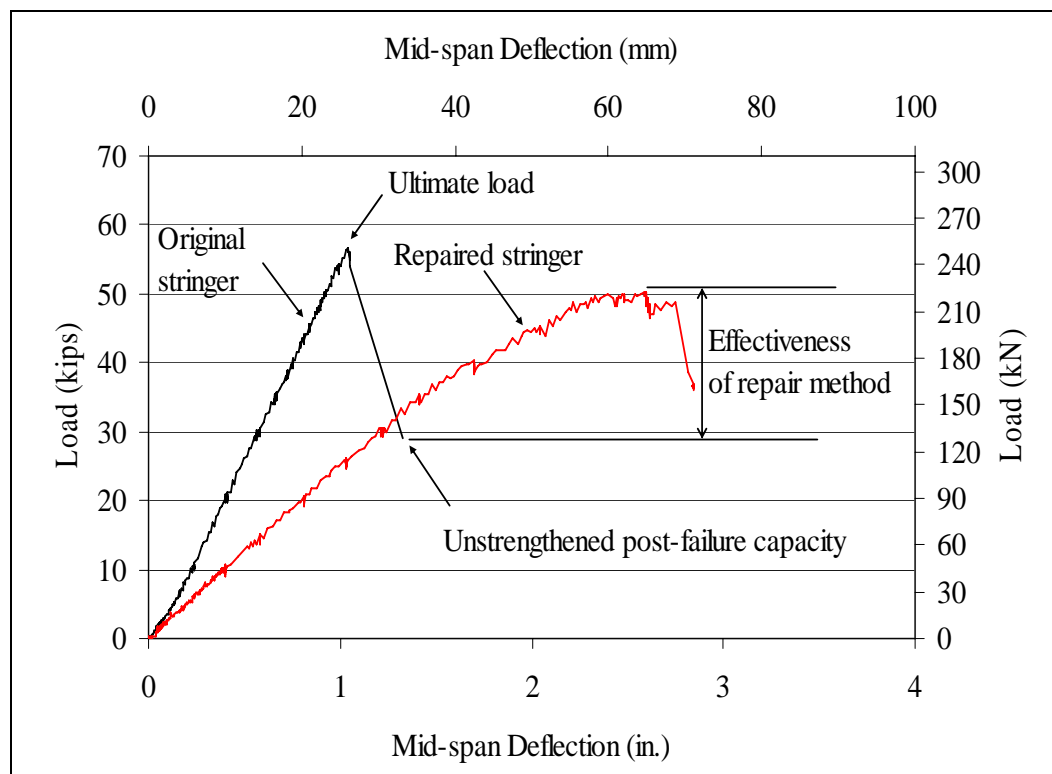
Figure 65. Effectiveness of a repair method.

Repaired stringers were again loaded to failure, after repair techniques were applied. The effectiveness of the repairing technique was determined by comparing the unstrengthened postfailure capacity of original stringer to ultimate strength of repaired stringer. This idea is shown graphically in Figure 65. The average deflection measured by the LVDTs at midspan is used for all graphs in this study.

For example, specimen C2 had checks over its entire length. When the stringer failed, load dropped to a certain level, which was called the unstrengthened postfailure capacity. It is this amount of load that the failed stringer is able to carry. After specimen C2-R was repaired, the repaired stringer was again loaded to failure. The repaired ultimate load was compared to the unstrengthened postfailure capacity of the original stringers to determine the effectiveness of repair method.

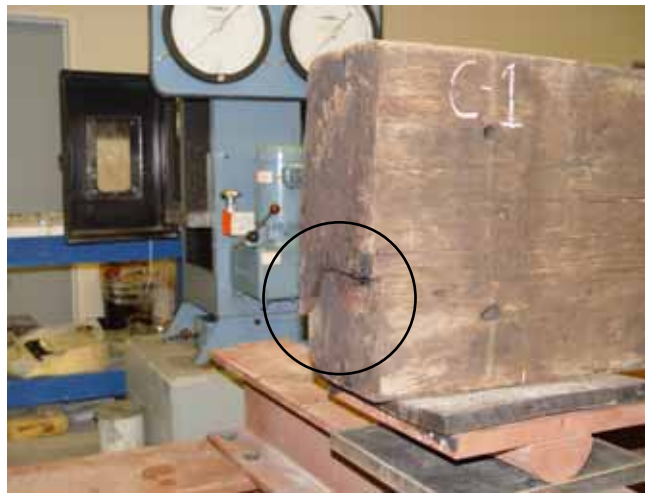
Figure 68. Horizontal sliding on support face after shear failure of stringer C1.

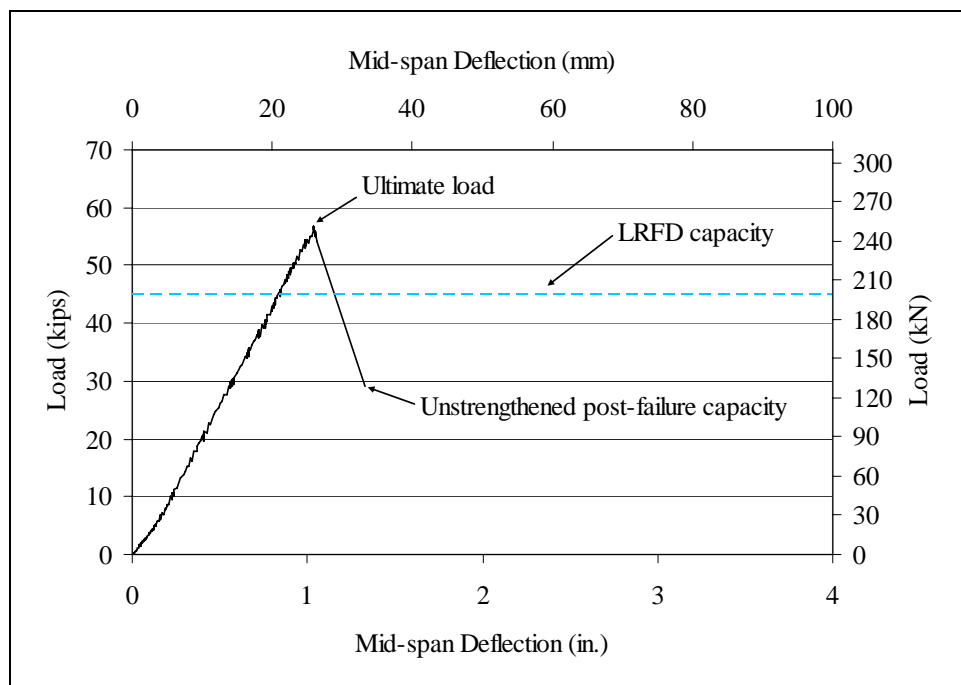
Figure 69. Load-deflection curve for stringer C2.

The load-deflection behavior for stringer C2 was linear up to the ultimate load, as seen in the load-deflection curve in Figure 69. The stringer failed in horizontal shear. The ultimate load was 254 kN (57 kips) at a displacement of 26 mm (1.02 in.). Following the horizontal shear failure, the load dropped to 129 kN (29 kips) which was the unstrengthened postfailure capacity. Horizontal sliding was only observed at one support face. Horizontal cracks at failure were close to the center of the cross section.

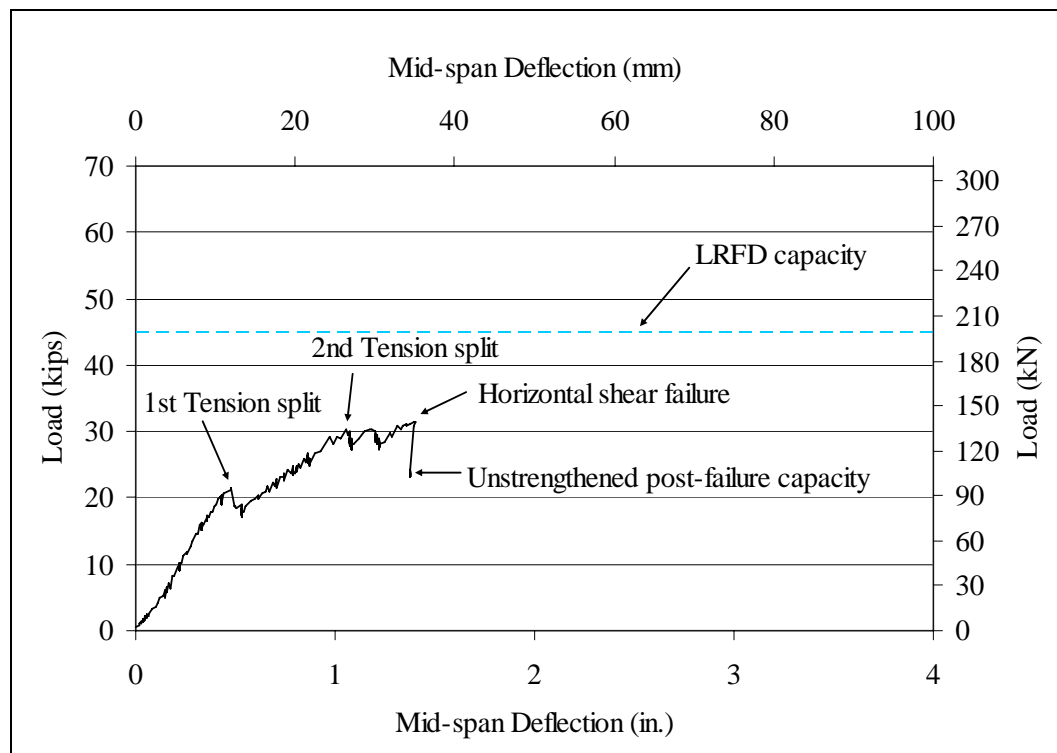
Figure 70. Load-deflection curve for stringer C3.

The load-deflection relationship for stringer C3 was linear until the timber cracked in the tension zone at a load of 98 kN (22 kips), as seen in the load-deflection curve in Figure 70. The supported load dropped to 76 kN (17 kips) after tensile cracking. The stringer then gained a load capacity up to 138 kN (31 kips) where crushing occurred, and then the timber cracked again in tension at the midspan. A close-up of the second tension failure is shown in Figure 71. The stringer then continued to gain load until, the stringer failed in horizontal shear. This was the ultimate load of 142 kN (32 kips), and a midspan deflection was 36 mm (1.40 in.). After the horizontal shear failure, the unstrengthened postfailure capacity was 102 kN (23 kips).

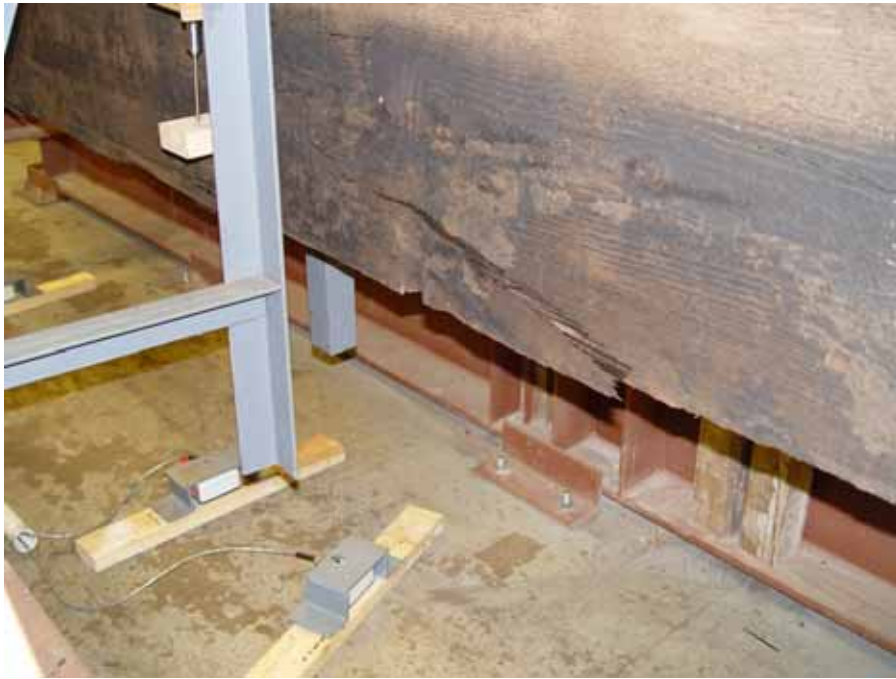
Figure 71. Splinter at the midspan on stringer C3.

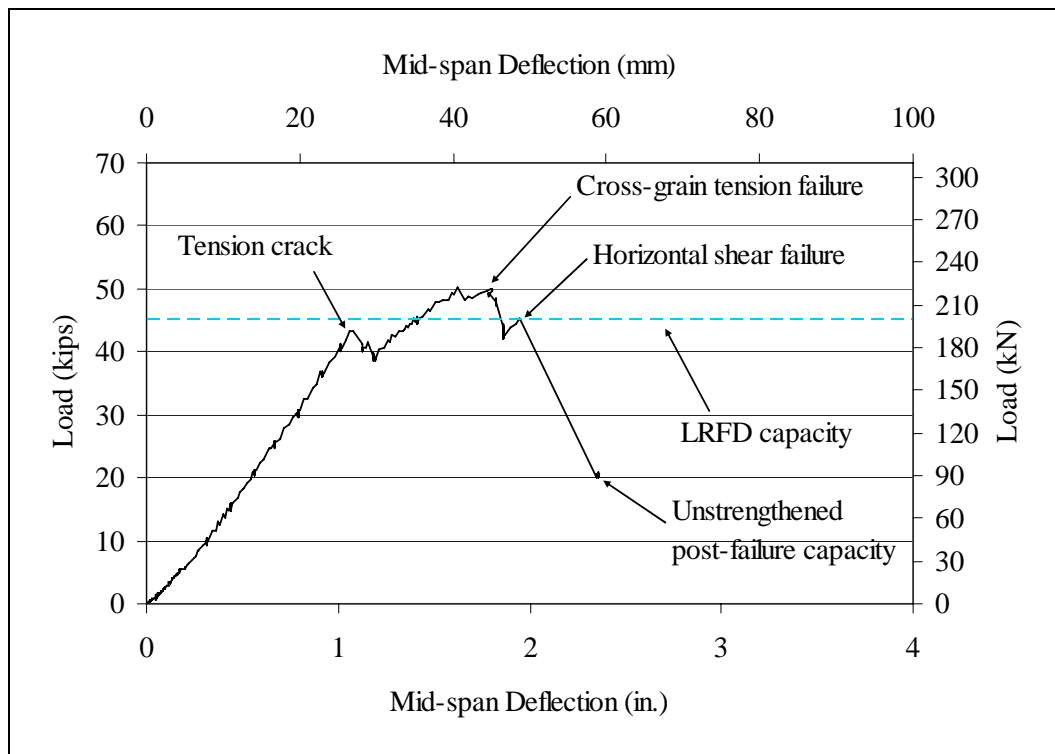
Figure 72. Load-deflection curve for stringer C4.

The initial slope of load-deflection curve for stringer C4, shown in Figure 72, was linear until the timber cracked in the tension zone at 182 kN (41 kips) causing a drop in the supported load to 173 kN (39 kips). The stringer underwent additional deflection with increasing load carrying capacity until the ultimate load was reached at 222 kN (50 kips). Several tension cracks and splinters were observed at the ultimate load. The ultimate load at failure was 222 kN (50 kips), and the midspan deflection was 46 mm (1.80 in.). The stringer had cross-grain tension failure at this ultimate load, and then the load dropped to 187 kN (42 kips). The failure split is shown in Figure 73. With a decreased stiffness, the load capacity again increased to 200 kN (45 kips) where the stringer had sudden horizontal shear failure, causing a drop in the supported load to 89 kN (20 kips). This was the unstrengthened postfailure capacity. The experiment was terminated after the horizontal shear failure. The horizontal shear crack was not directly across the width of the cross section, as shown in Figure 74.

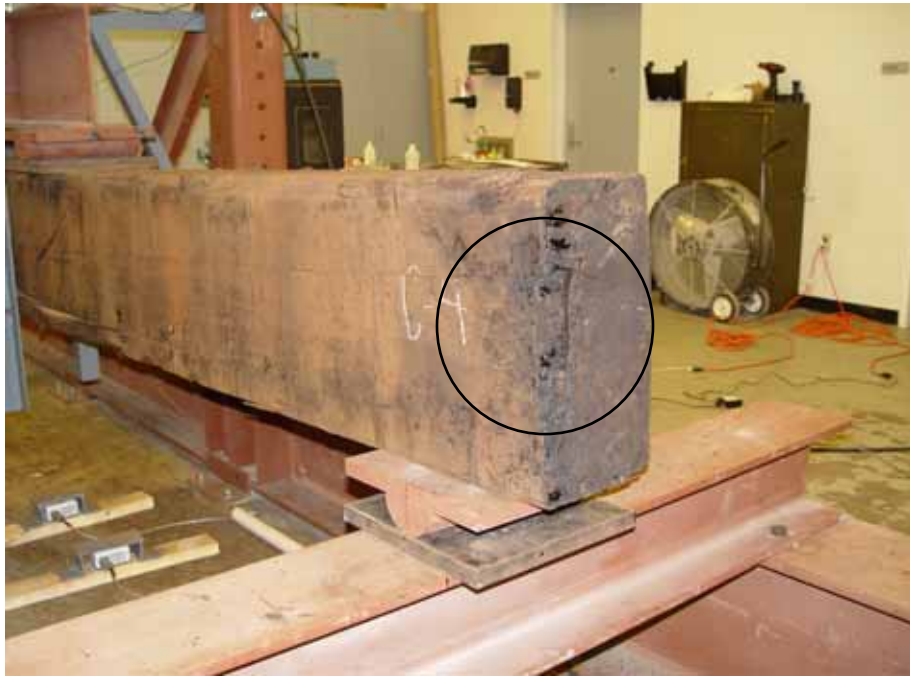
Figure 74. Horizontal shear failure on stringer C4.

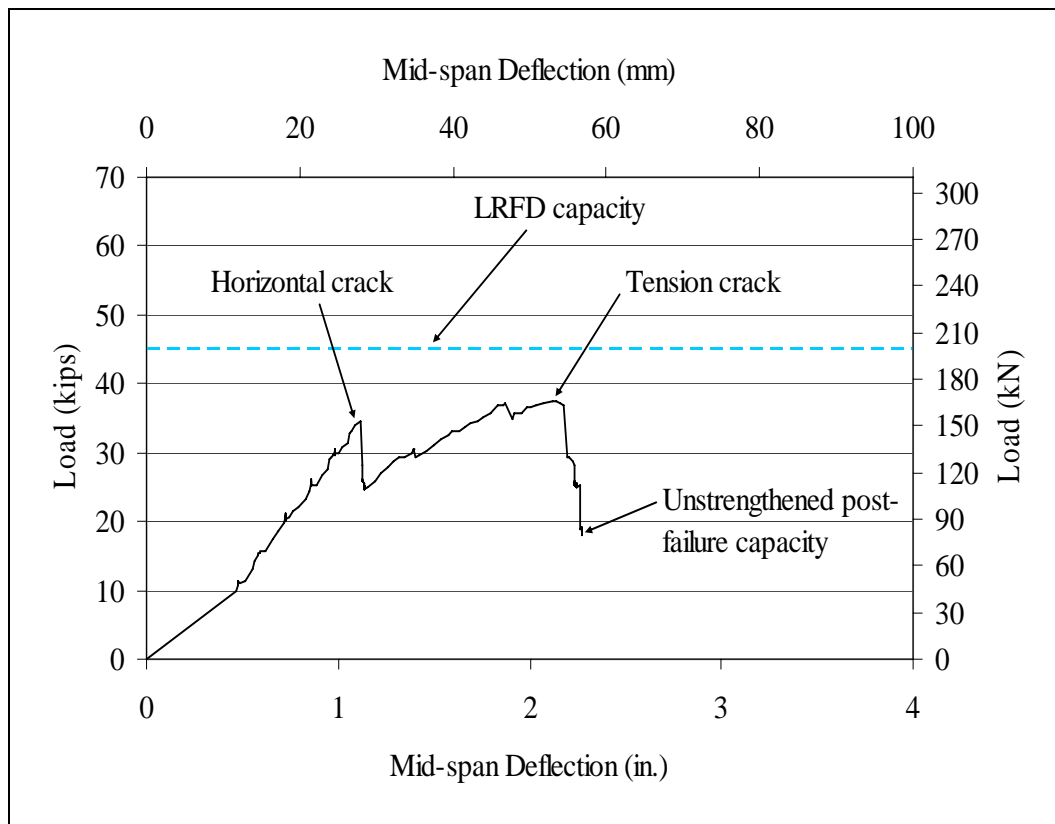
The initial slope of the load-deflection curve for stringer C5 is shown in Figure 75. The curve was linear until the timber cracked horizontally at 151 kN (34 kips), causing a drop in the supported load to 111 kN (25 kips). With the decreased stiffness, the stringer carried additional load while undergoing additional deflection until the ultimate load was reached and the stringer failed in simple tension. The failure pattern of stringer C5 is shown in Figure 76. The ultimate load was reached at 169 kN (38 kips) and at a deflection of 54 mm (2.12 in.). The unstrengthened postfailure capacity was 80 kN (18 kips).

Figure 75. Load-deflection curve for stringer C5.

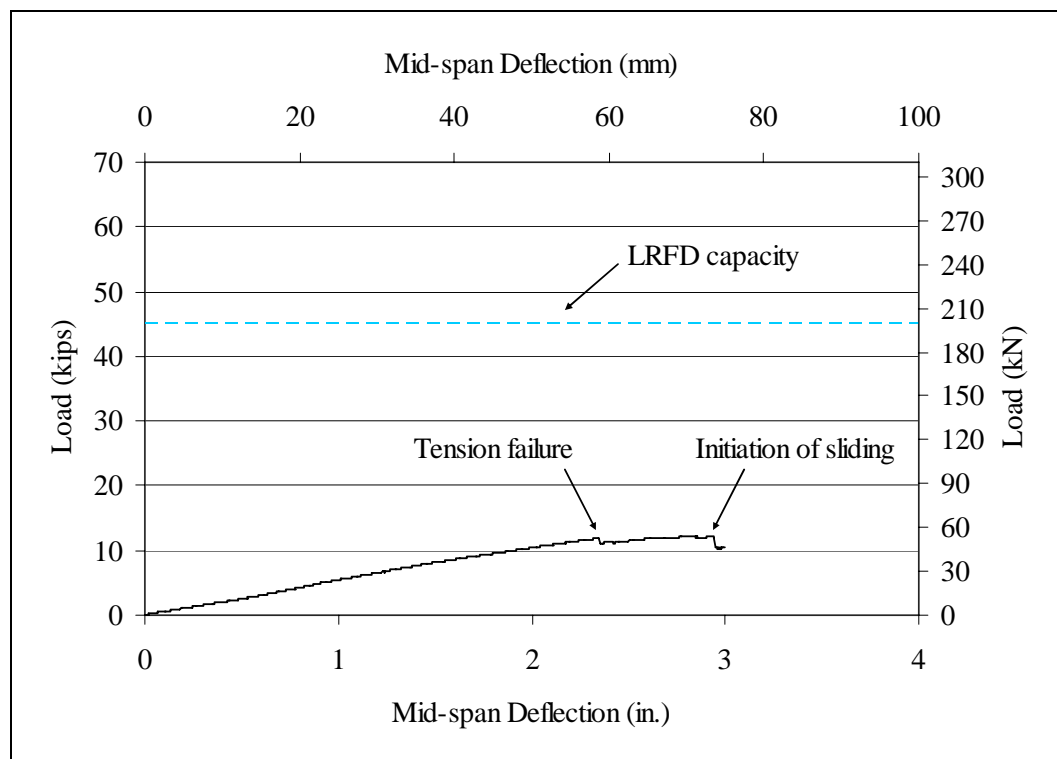
Horizontal sliding was observed at the support faces as the load increased, since stringer C6 had horizontal end splits prior to testing. The initial slope of the load-deflection curve for stringer C6, as shown in Figure 77, was linear until the timber cracked in tension at a load of 53 kN (12 kips). The stiffness in this portion was due to the sliding friction between the two sides of the horizontal splits. A tension crack formed at failure and is shown in Figure 78. At the ultimate load, the stringer reached the unstrengthened postfailure capacity, and then underwent additional deflection without any increase in load. The experiment was terminated when the postfailure capacity was reached.

Figure 77. Load-deflection curve for stringer C6.

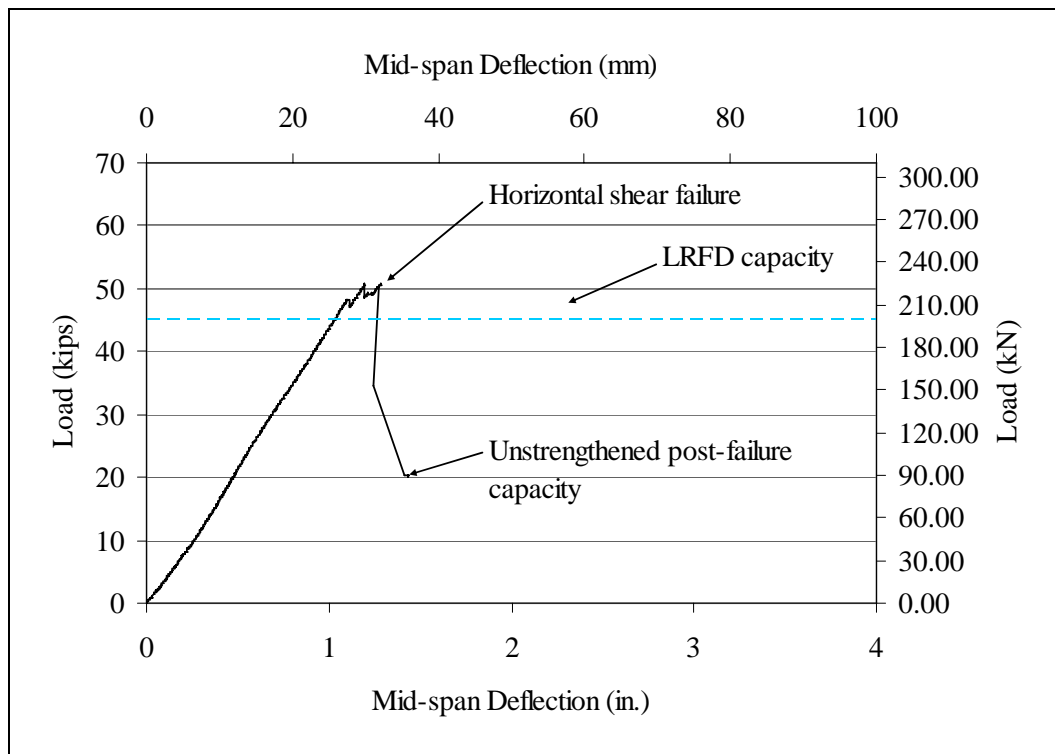
The initial slope of the load-deflection curve for stringer C7 is shown in Figure 79. It was linear until the timber cracked in tension at 222 kN (50 kips), causing a small drop in the load capacity to 214 kN (48 kips). As the load increased to failure, the stringer failed in horizontal shear, as shown in Figure 80. The ultimate load at failure was 227 kN (51 kips) at a displacement of 33 mm (1.29 in.). The unstrengthened postfailure capacity was 89 kN (20 kips).

Figure 79. Load-deflection curve for stringer C7.

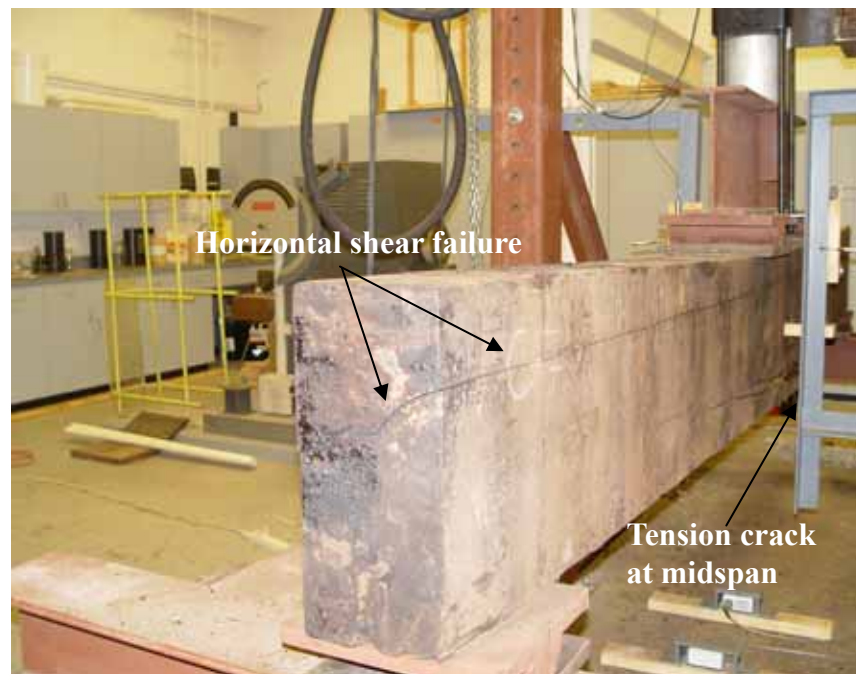
Figure 80. Horizontal shear failure and tension crack on stringer C7.

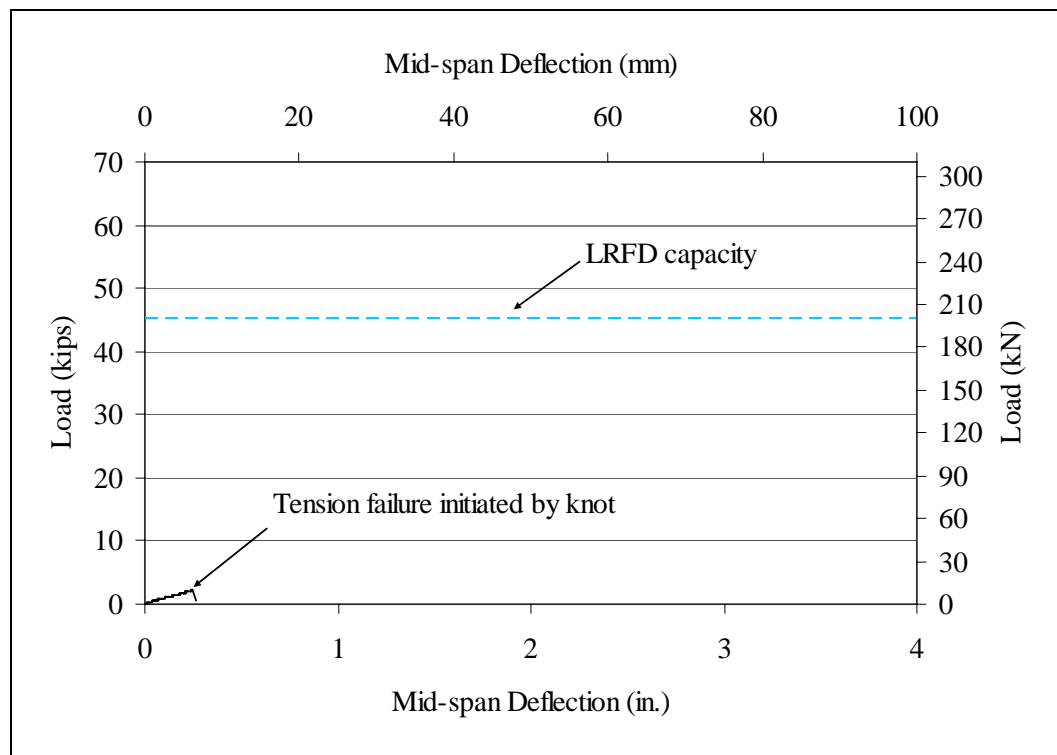
Failure was caused in stringer C8 by a tension crack initiated by a knot. The ultimate load at failure was 9 kN (2 kips), and the midspan deflection was 6 mm (0.24 in.), as shown in Figure 81. As it was explained in Chapter 2, “Literature review, Structural behavior of timber, Natural defects in wood,” the ultimate strength of the stringer was reduced due to the presence of knots. These knots are shown in Figure 82.

Figure 81. Load-deflection curve for stringer C8.

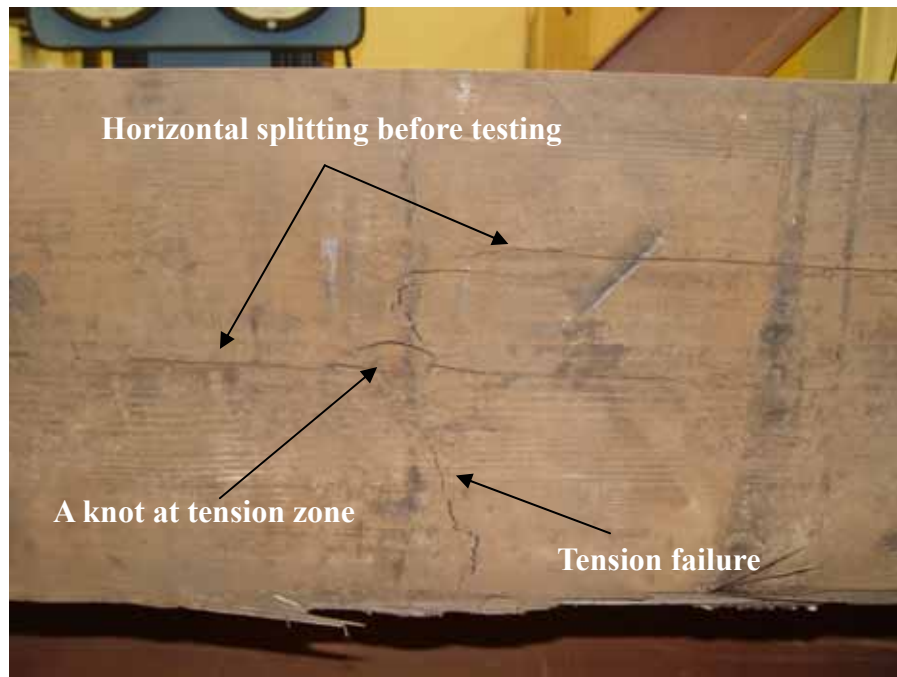
Figure 82. Tension failure initiated by a knot on stringer C8.

Another factor which reduced the load capacity of the timber stringers was the presence of knots. Timber stringers C8 and C9 developed tension cracks due to knots that were oriented vertically from the bottom to top of the stringers. These stringers had an 82% lower load capacity than the stringers with checks, as seen in Table 12. As expected, the natural defects decrease the strength and durability of timber members. The discontinuities introduced by the knots in stringers C8 and C9 reduced the ultimate strength by 95% and 70%, respectively. The attempted repair methods proved to be unfeasible for these two stringers.

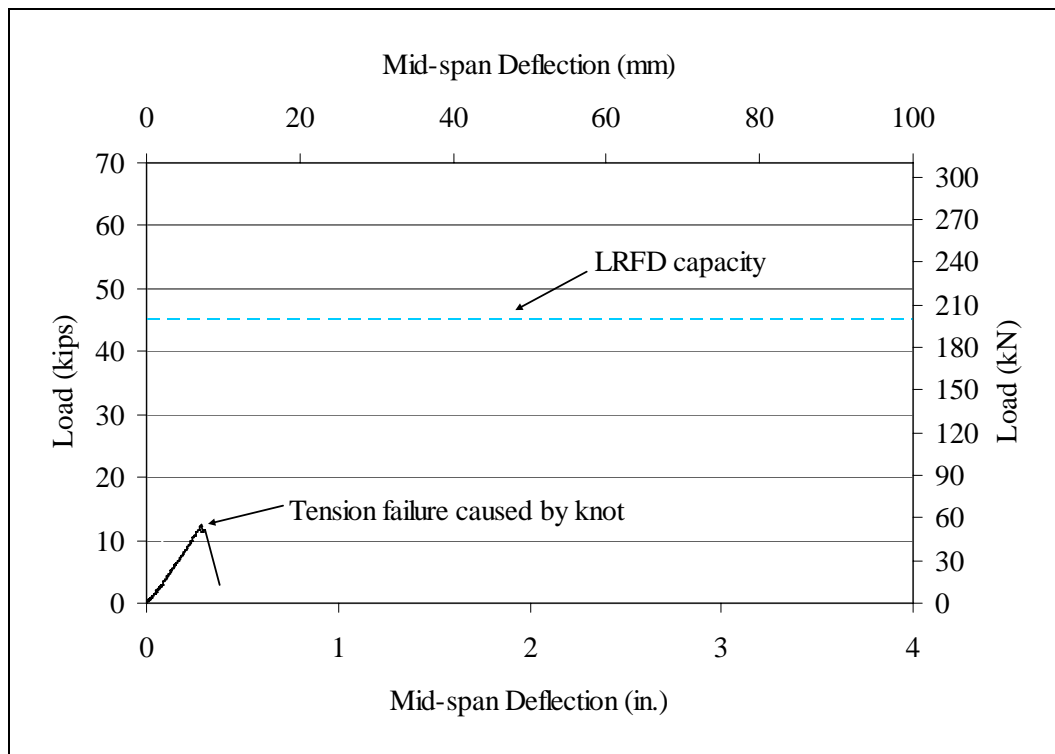
The load-deflection curve for stringer C9, shown in Figure 83, was linear until the stringer suffered a tension crack initiated by a knot under the loading point, as seen in Figure 84. The tension crack propagated upward into the compression zone, and as a result caused the stringer to fail at a relatively lower strength. The ultimate load was 56 kN (12.5 kips) at a deflection of 7 mm (0.29 in.).

Figure 83. Load-deflection curve for stringer C9.

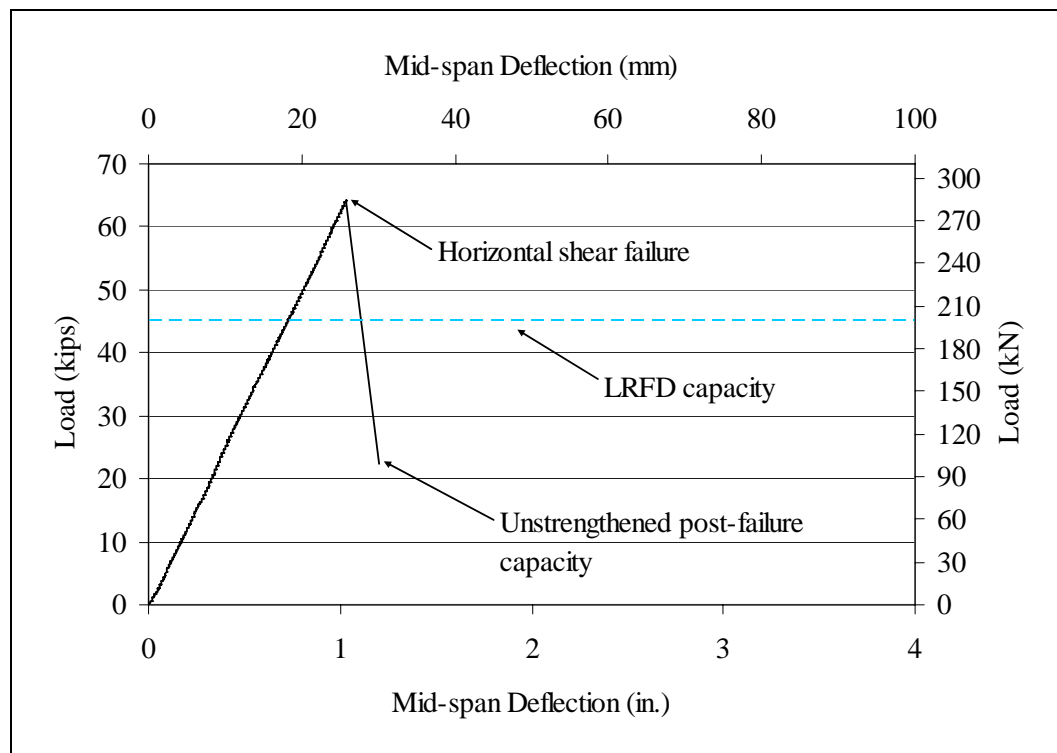
The stringer behaved linearly up until it reached the ultimate load, as seen in load-deflection curve shown in Figure 85. Stringer C10 failed in horizontal shear, and horizontal sliding was observed at the support face. The ultimate load at failure was 285 kN (64 kips) at a displacement of 26 mm (1.03 in.). The unstrengthened postfailure capacity was 98 kN (22 kips).

Figure 85. Load-deflection curve for stringer C10.

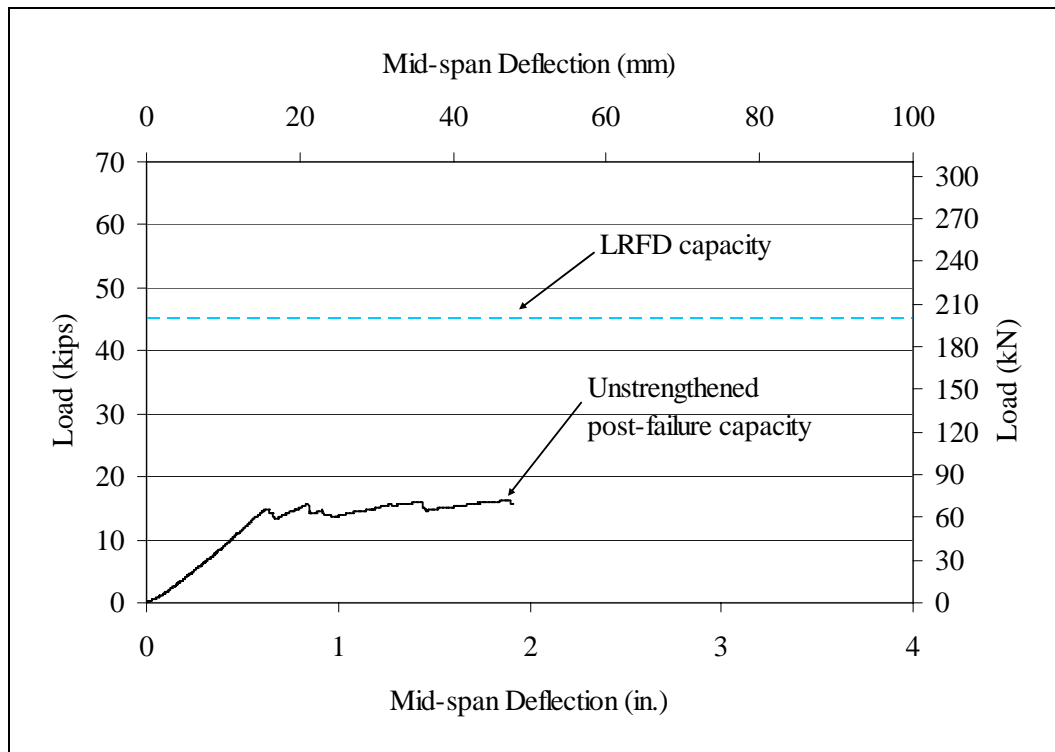
Horizontal sliding was observed at the support faces of stringer C11 as the load increased. There were existing horizontal end splitting before testing. The initial portion of the load-deflection curve, shown in Figure 86, was linear until the timber cracked again in horizontal shear at 67 kN (15 kips), causing a drop in the supported load to 58 kN (13 kips). The stringer underwent additional deflection with the increased load carrying capacity until postfailure capacity was reached. This large deflection was caused by the two pieces sliding over one another. Several horizontal cracks were observed as a result of excessive deformation. The unstrengthened

postfailure capacity was 76 kN (17 kips) at a deflection of 48 mm (1.90 in.). The experiment was terminated at the postfailure capacity.

Figure 86. Load-deflection curve for stringer C11.

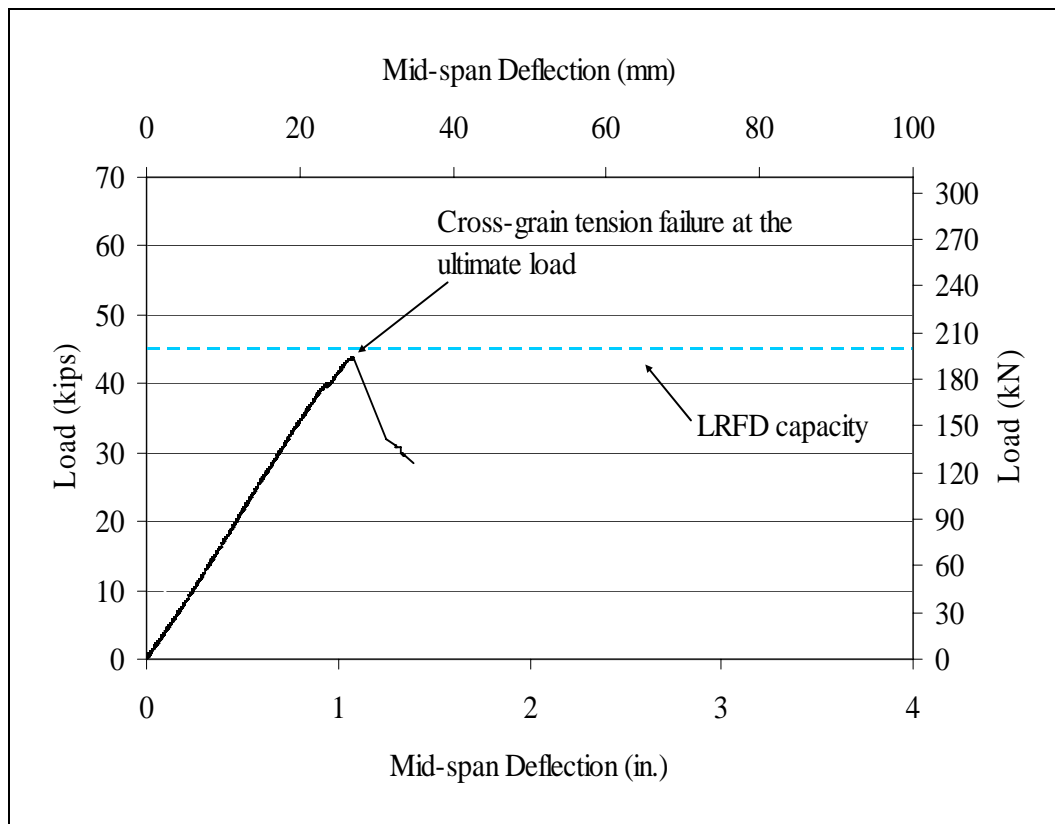
The initial slope of the load-deflection curve for stringer C12, shown in Figure 87, was linear until the stringer cracked in the tension zone causing the capacity to drop. The stringer had a cross-grain tension failure, as shown in Figure 88. The ultimate load resisted by the stringer was 196 kN (44 kips) at a displacement of 27 mm (1.07 in.). After the tension failure, the unstrengthened postfailure capacity was 129 kN (29 kips).

Figure 87. Load-deflection curve for stringer C12.
